Parthé S., Welker A., Meier C., Knorr B., Schumacher S. Application study on aerosol-reducing hygienic siphons for control of a 4MRGN *Pseudomonas aeruginosa* outbreak on a neurological early stage rehabilitation ward. *Hyg Med* 2016; 41(12): E194–E199.

# Application study on aerosol-reducing hygienic siphons for control of a 4MRGN *Pseudomonas aeruginosa* outbreak on a neurological early stage rehabilitation ward

## Summary

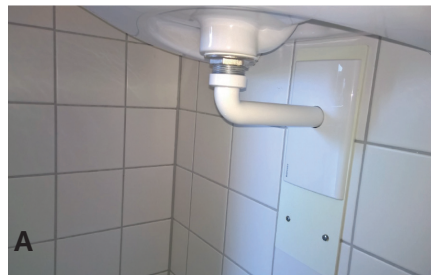
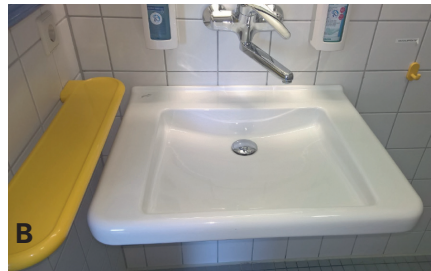
The washbasins concerned are flat washbasins specially designed for rehabilitation purposes with wheelchair-friendly, L-shaped corner waste pipes to facilitate patient exercises during wash training (see Fig. 1a and b).

Figure 1: A: L-shaped siphon trap and B: Flat washbasin of rehabilitation ward.

Since it was suspected that L-bend pipes compared with the conventional S-bend pipes were more likely to permit retrograde reflux, in November 2015 the L-corner pipes of all washbasins on the impli-

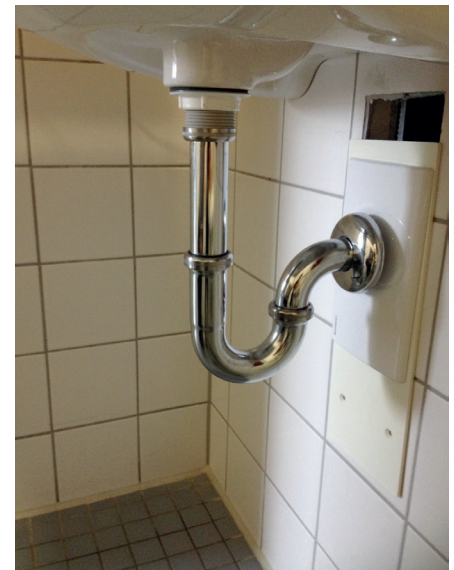
Figure 2: S-shaped siphon trap.

cated ward were replaced with traditional S-pipes (see Fig. 2). Regardless of the latter, this was a technical requirement for installation of the HygieneSiphons.

Already partial sanitization of the waste water system (replacement of L-pipes with S-pipes) reduced the isolation rate of 4MRGN *P. aeruginosa* in two of the three selected washbasins (see Table 1, 14.11.15 versus 31.7.15).

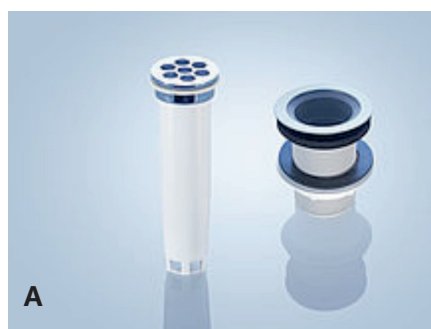
HygieneSiphons are disposable devices that are inserted into the washbasin drain trap. They prevent retrograde contamination of the washbasin through the reflux of microorganisms from the drain trap. The findings of studies conducted hitherto by the firm Aqua free GmbH into the effectiveness of the HygieneSiphons had been based exclusively on in vitro testing of their capacity to retain bioaerosols from the drain trap formed above the seal water [3]. Nor were any study findings available so far on the clinical impact of installation of HygieneSiphons.

Thanks to their design, the HygieneSiphons marketed by the firm Aqua free GmbH prevent aerosol reflux from the drain trap (see Fig. 3a and Fig. 3b).

Figure 3: A: HygieneSiphon – Inlet and permanent drain valve I. B: Function of HygieneSiphon compared with that of standard siphon [7]. (Figures with kind permission of the firm Aqua free).

lower two-digit euro range. They should be replaced at three-monthly intervals as recommended by the firm Aqua free GmbH.

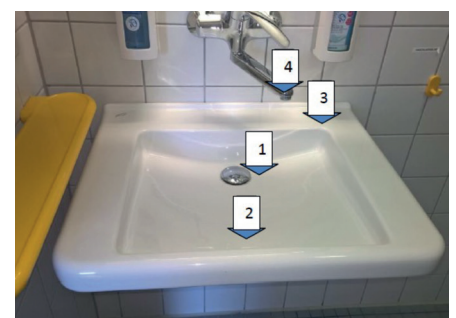
Figure 4: Illustration of microbiology sampling points.

1. Contact plate sample directly beside drain
2. Contact plate sample from front basin rim
3. Contact plate sample from rear basin rim
4. Swab from aerator.

2. The three patient washbasins fitted with HygieneSiphons (washbasins A–C) were microbiologically monitored over a period of four weeks (November to December 2015). Contact plate samples were taken for microbiology testing of the washbasins (close to the drain, washbasin rim at the front and rear), and swabs were obtained from the aerators (see Fig. 4), in each case on day 1, 7, 14, 21 and 28 after insertion of the HygieneSiphons. All tests were carried out with an empty washbasin, after filling the basin with water and after allowing the water to drain (simulation of wash training exercises).
